Schofield Barracks, Wheeler Army Airfield & Fort Shafter Oahu, Hawaii

Crash Location Enhancement Studies

March 2000

Gannett Fleming, Inc.

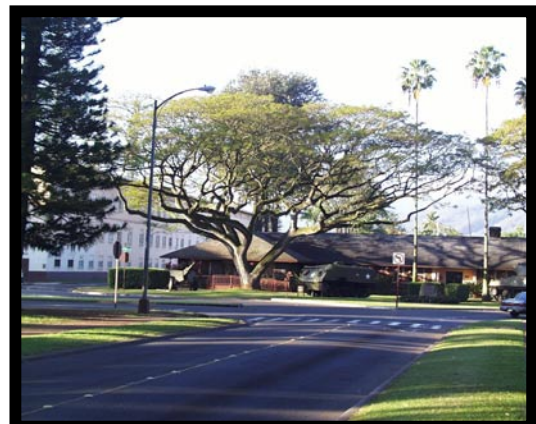
Figure 37. Intersection of Waianae Avenue and Macomb Road (southward view)

The construction of the Kolekole Connector Road Project will improve traffic flow in the east-west directions. However, traffic using Macomb Gate will continue to encounter circuitous travel patterns to gain access to most parts of the installation. Based on field observations, a more direct north-south access is needed to relieve traffic congestion. At the present time, traffic entering the installation from Macomb Road must turn right and then turn left onto other roadways to gain access to other areas of the installation. A significant amount of traffic entering Macomb Gate utilizes Heard Avenue to travel southward. This pattern is partially responsible for operational deficiencies at the five-legged intersection of Trimble Road, Foote Avenue and Heard Avenue. This intersection is discussed in subsequent sections of this study.

To relieve traffic congestion, a north-south connector is recommended from Macomb Road to the Kolekole Connector Road (fig 38). The Macomb – Kolekole Connector should roughly follow the alignment as existing Kolekole Avenue from where it turns northward to Macomb Road.

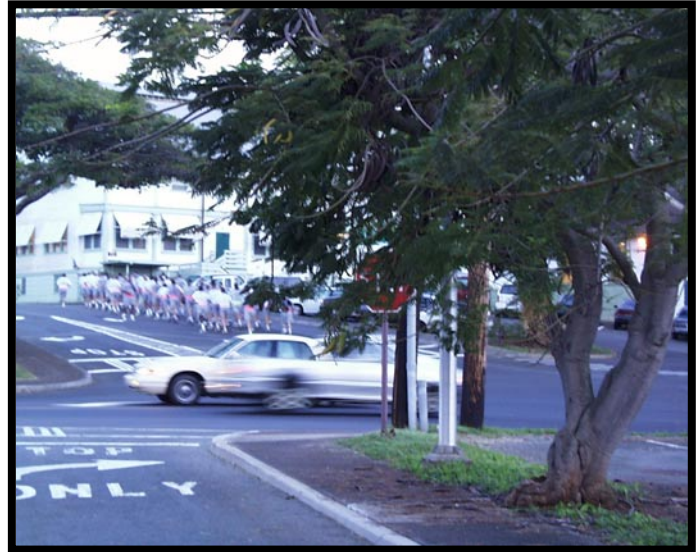
Figure 39. Intersection of Funston Road, C Street and G Street (northward view)

- The R1-1 (STOP) sign on the northbound approach cannot be seen by motorists due to vegetation growth (fig 39). Vegetation should be trimmed to provide proper sight distance.

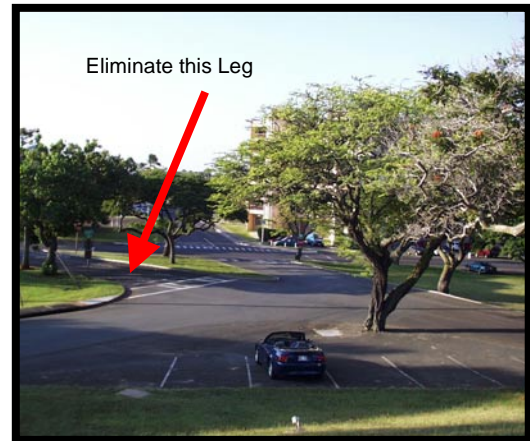
Figure 43. Intersection of Wisser Road, Pierce Street and Macomb Road (southward view)

The intersection of Wisser Road, Pierce Street and Macomb Road is a confusing intersection due to its many legs and crossings (fig 43).

One solution is to eliminate the northeast quadrant (short connector road at left in fig 43) of this intersection, thereby reducing the number of conflict points. The elimination of this connection would create a standard four-way STOP controlled intersection that is less confusing than the present configuration. This modification may require that the radii on the northeast quadrant be increased to accommodate larger vehicles. The Macomb Road approach can be aligned with Pierce Street such that it becomes a T-intersection.
